Grasse River Superfund Site Public Information Session

Wednesday, September 11, 2024 6:00pm-7:30pm

**Grasse River Remediation Project**

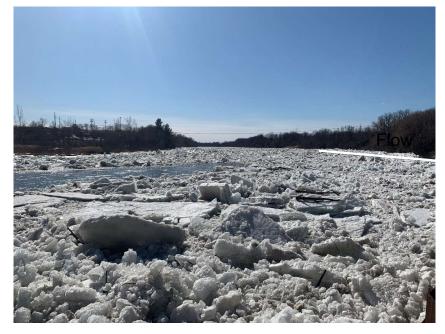
#### 2022 Ice Jam Review

Route 131 Staging Area Looking Upstream Tuesday March 22 – 3:10 p.m.
